# Property Condition Report

**Case Number:** 151-553569

**Full Address:** 757 Kingston Circle  
Brownsburg, IN 46112

**Inspection Date:** 08-02-2005

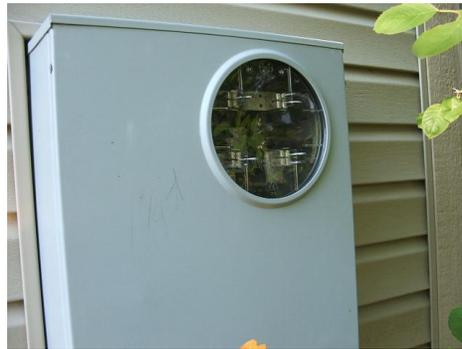
Meter Number: capped

2. Capped Meter

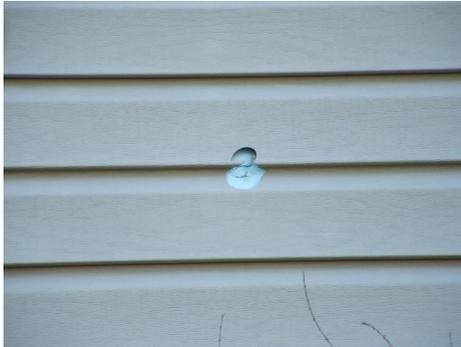
4. Siding Damage

Description	Amount	Price	Reason
Replace missing light fixtures	3 each	40.00	
Repair siding		50.00	
Remove fencing		30.00

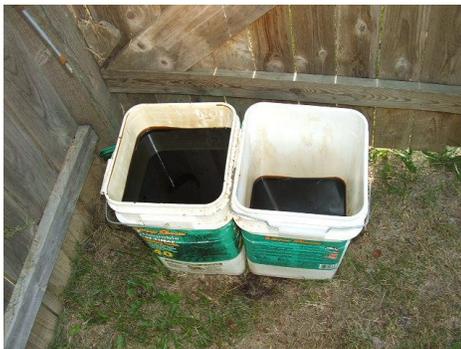
7. Buckets Of Oil On Site

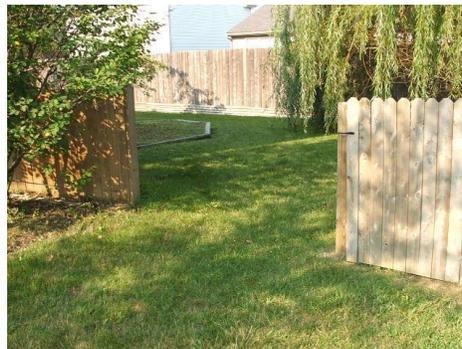
Checkpoint	Rating	Comment
<b>Balconies:</b>	NA	
<b>Carports:</b>	NA	
<b>Debris:</b>	S	
<b>Decks/Deck Steps:</b>	S	
<b>Driveway:</b>	S	
<b>Eaves:</b>	S	
<b>Entry Locks:</b>	S	
<b>Exterior Door/Locks:</b>	S	
<b>Fencing/Gates:</b>	NA	There are some areas of the fencing that are missing.
<b>Garage Door:</b>	S	
<b>Garage Door Opener:</b>	S	
<b>Landscape:</b>	S	
<b>Lawn Care:</b>	S	
<b>Leaf Removal:</b>	S	
<b>Patio:</b>	NA	
<b>Pool/Spa:</b>	NA	
<b>Porches:</b>	S	
<b>Railings:</b>	S	
<b>Retaining Walls:</b>	NA	
<b>Sheds and Outbuildings:</b>	NA	
<b>Sidewalks:</b>	S	
<b>Siding Condition:</b>	MR	The exterior siding is damaged at the back: 2 square inches
<b>Snow Removal:</b>	NA	
<b>Exterior Steps:</b>	NA	
<b>Storm/Screen Windows:</b>	S	
<b>Storm/Screen Doors:</b>	S

8. Missing Fence Section

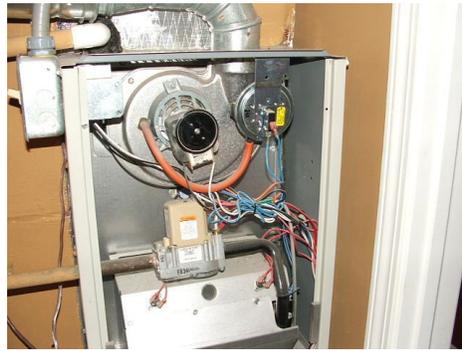
14. Furnace

Checkpoint	Rating	Comment
<b>A/C Component Cond.:</b>	S	
<b>Boiler:</b>	NA	
<b>Coil:</b>	S	
<b>Coil Fins:</b>	S	
<b>Condens. Pipe:</b>	S	
<b>Controls:</b>	S	
<b>Draft Device:</b>	NV	
<b>Duct Work:</b>	S	
<b>Electric Heat:</b>	NA	
<b>Evaporator:</b>	NV	
<b>Fans:</b>	S	
<b>Filter:</b>	U	The HVAC filter needs replacing.
<b>Fireplace:</b>	NA	
<b>Flue Pipe/Draft:</b>	S	
<b>Furnace System:</b>	U	A gas furnace supplies the heat. The furnace would not respond to the thermostat.
<b>Gas Lines:</b>	S	
<b>Heat Exchanger:</b>	NV	The heat exchanger is sealed and not visible.
<b>Heat Pump:</b>	NA	
<b>Inside Fan Motor:</b>	NV	The fan motor could not be tested.
<b>Oil Tank:</b>	NA	
<b>Oil Tank Vent:</b>	NA	
<b>Refrigerant Line:</b>	S

Checkpoint	Rating	Comment
Supply Returns:	S	
Temp. Drop Test:	MG	The temp drop test could not be performed because the system would not respond to the thermostat.
Thermostat:	U	The thermostat would not control the system.
Vapor Barrier:	S	
Ventilation:	S

*The HVAC system was not in working condition at the time of inspection.*

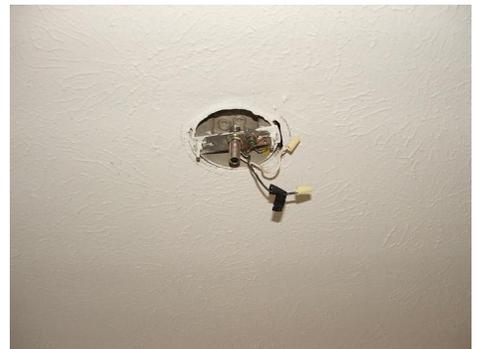
Checkpoint	Rating	Comment
<b>Appliance Wiring:</b>	S	
<b>Bath GFCI:</b>	S	
<b>Breaker Cond.:</b>	S	
<b>Exterior GFCI:</b>	S	
<b>Exterior Wiring:</b>	S	
<b>Ground/Bonding:</b>	S	
<b>HVAC Wiring:</b>	S	
<b>Interior Wiring:</b>	S	
<b>Kitchen GFCI:</b>	S	
<b>Lighting Fixtures:</b>	MG	There are 3 missing light fixtures.
<b>Panel Box:</b>	S	
<b>Rec. Location:</b>	S	
<b>Service Attach:</b>	S	
<b>Service Meter:</b>	MG	The service meter is missing and capped.
<b>Sub Panel Box:</b>	NA

21. Missing Fixture
